3 DETAILED OBSERVATIONS ON THE TANKS THAT WERE INSPECTED

3.1 TANK A

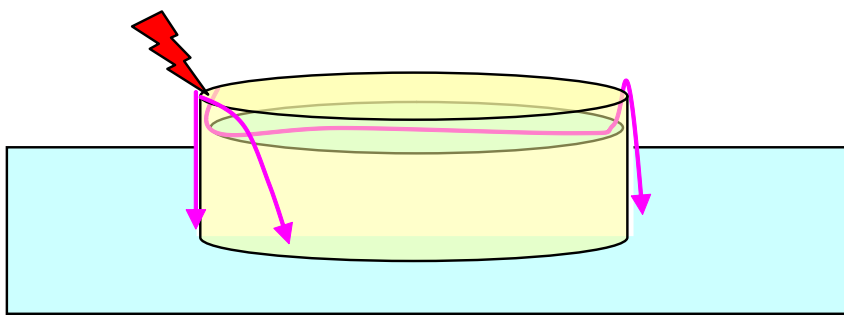
Figure 1 Current flow

- The tank floor is generally 8 mm thick and welded to the tank shell walls. The significance of this is that the skin effect will cause the fast pulses of lightning current to flow exclusively as a thin outside layer. So for a strike to the top of the shell of an open FRT, much of the current will flow as a surface layer down the outside surface of the shell. Some will also flow down the inside surface of the shell to the level of the floating roof, cross via the shunts to the floating roof, flow across the top surface of the floating roof and then to the shunts on the opposite side of the tank, up the inside surface of the shell to the top, and then down the outside surface to ground. Current will enter the ground by flowing on the underside surface of the tank floor steel plates. This current flow is shown in Figure 1.

Thus no fast current will flow in structures or surfaces adjacent to the tank liquid.

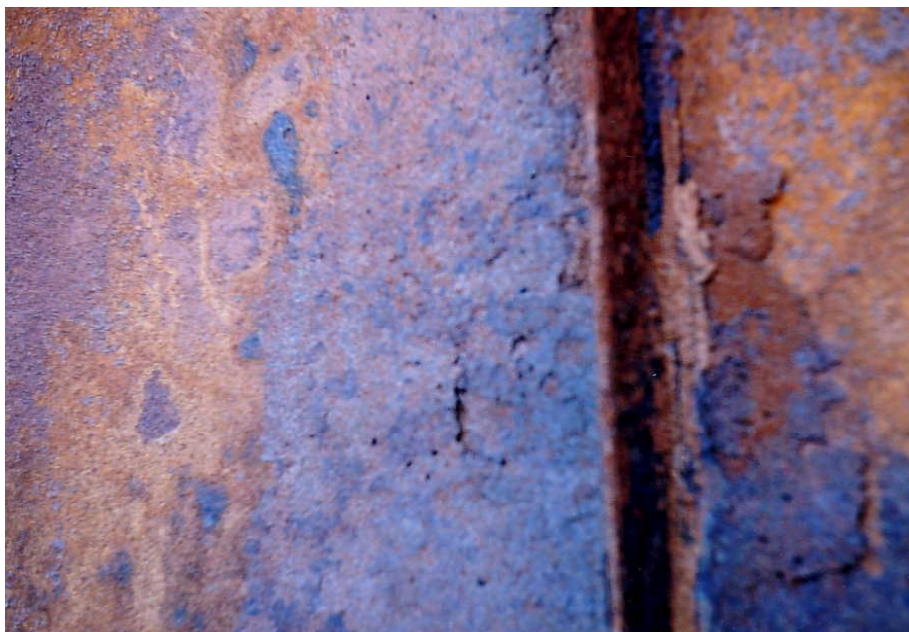
Photograph 1 Showing the corrosion inside a motor spirit tank. Although the picture is slightly blurred, it shows the flaking away of the rust on part of the surface

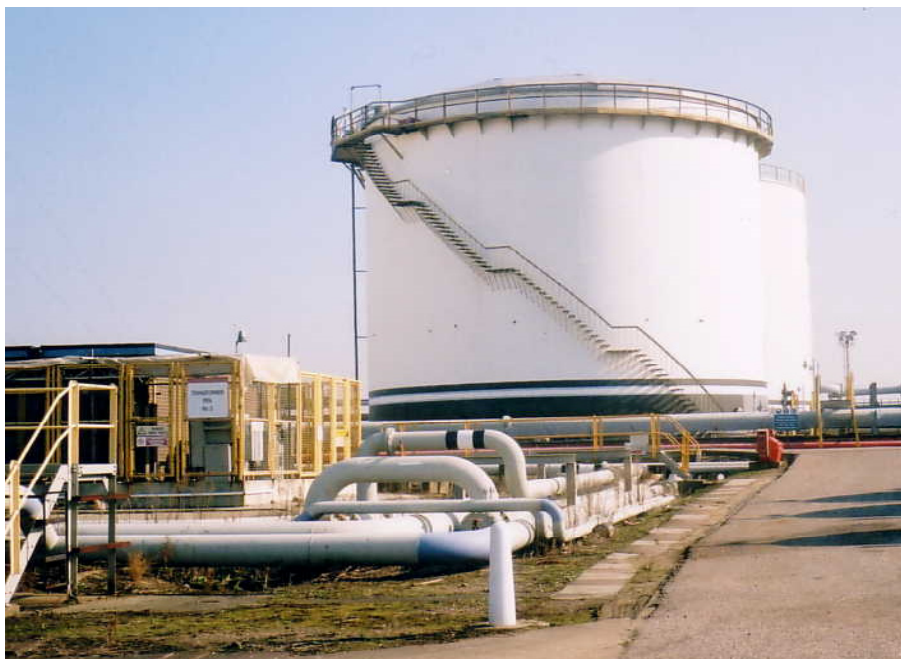
One geodesic roof tank was viewed at some distance (see Photograph 2), the roof of which was said to be of bolted construction, but the skin thickness of the aluminium panels is not known at the present. The steel cone roof tanks have steel at least 5 mm thick so they are able to carry the high current safely. There remains the possibility that an incendiary hot-spot could form on the back surface of an arc attachment point. This is discussed in EI-TN1-03 *Review of burn-through and hot-spot effects on metallic tank skins from lightning strikes*.

Photograph 2 Geodesic tank roof at refinery B
