An Experimental Study on Deterioration and Repairing of a Marine Concrete Structure

by Y. Takagishi, H. Ichikawa,
H. Tabuchi, and A. Moriwake

Synopsis: Load carrying capacity and fatigue strength before and after repairing were investigated for a coastal structure in Tokyo Bay, which was subjected to a serious damage by chloride during 15 years. Static and cyclic load tests together with investigation on effectiveness of repair were carried out on specimens taken from the site. It was found that the bearing and yielding capacities of deteriorated slab are 90% and 80%, respectively of those of sound structure. These losses were mainly caused by 10% loss of reinforcement corrosion. The specimens repaired by material with high tensile strength suggested brittle failure in static load test. It was also found that fatigue failure of deteriorated reinforcements was accelerated by pitting corrosion.

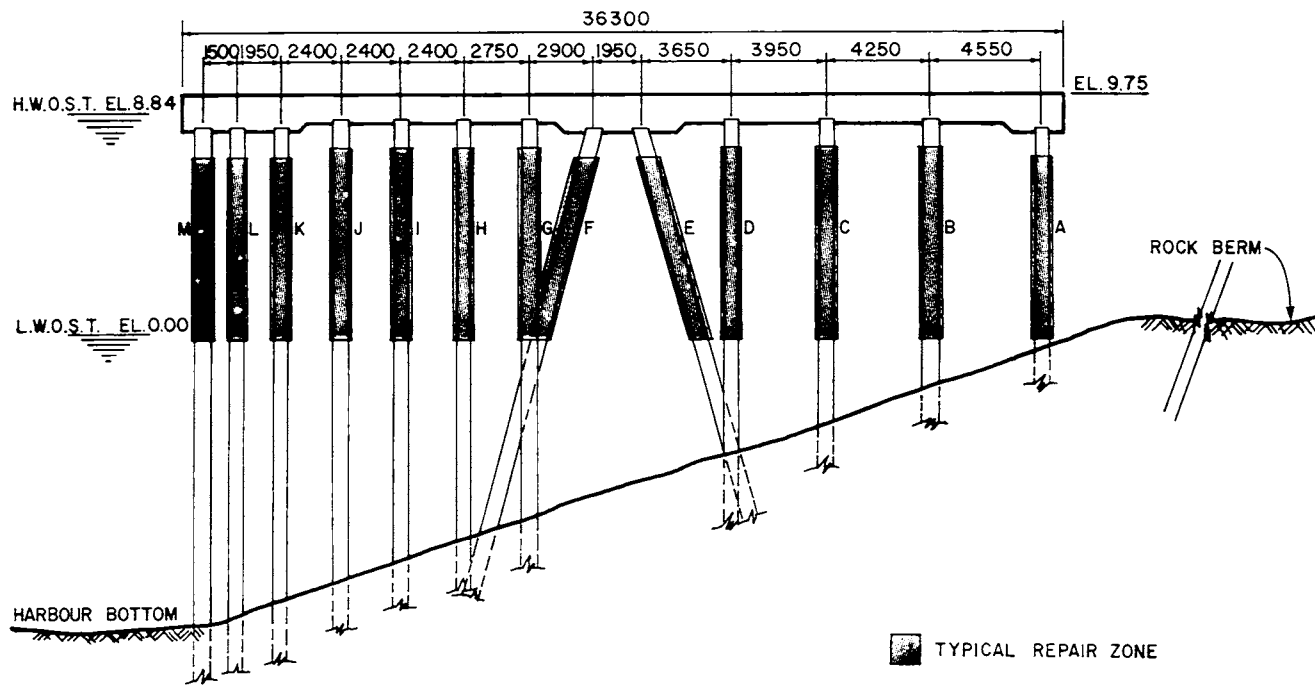
Fig. 5--Typical pile bent showing repair zone

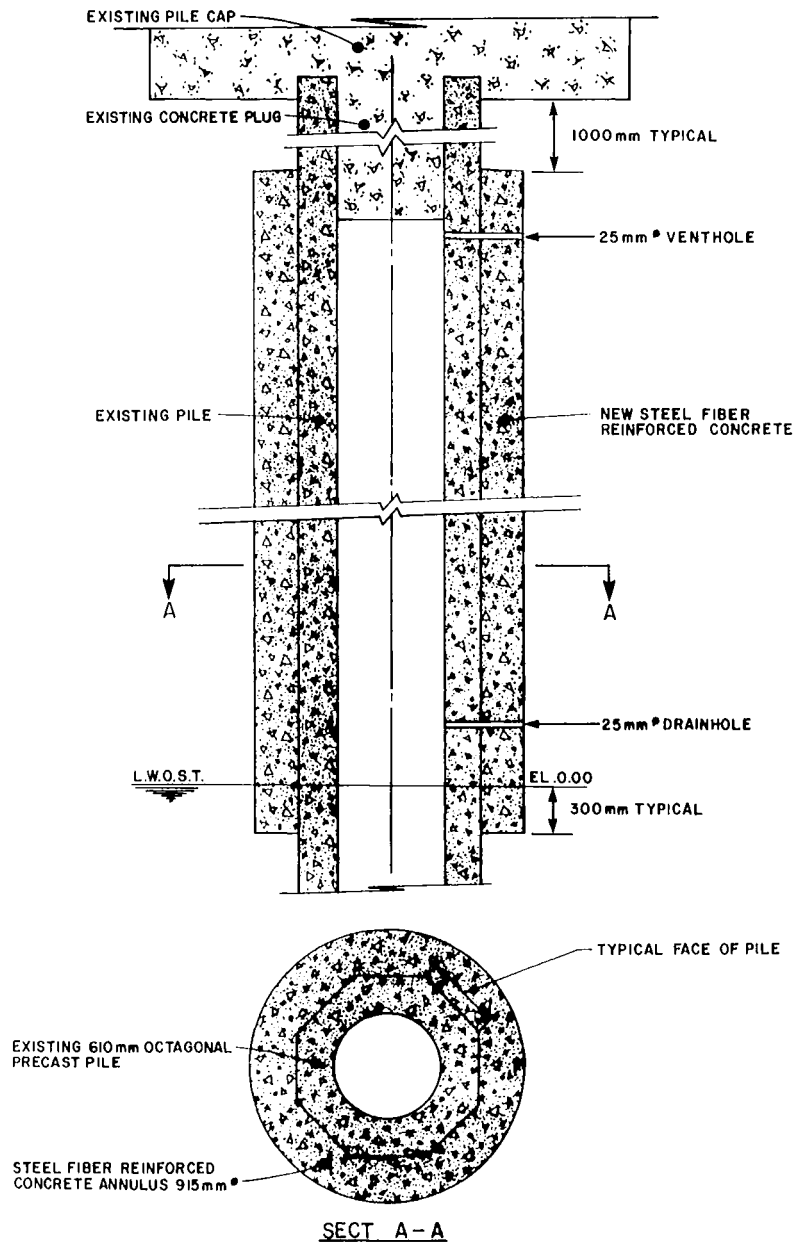
Fig. 6--Pile section showing SFRC jacket

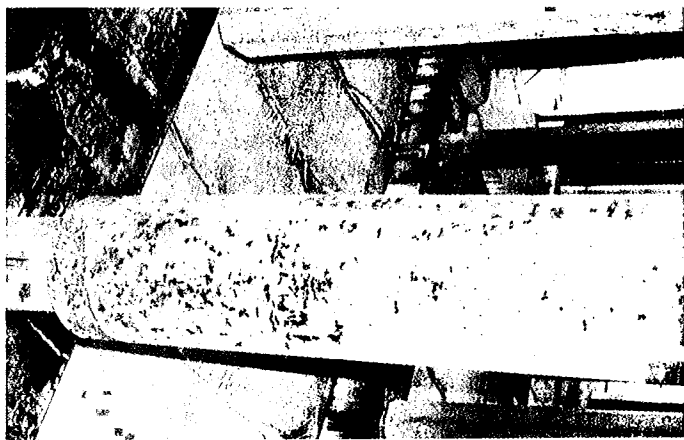
Fig. 8--Pile after repair — collated fibers

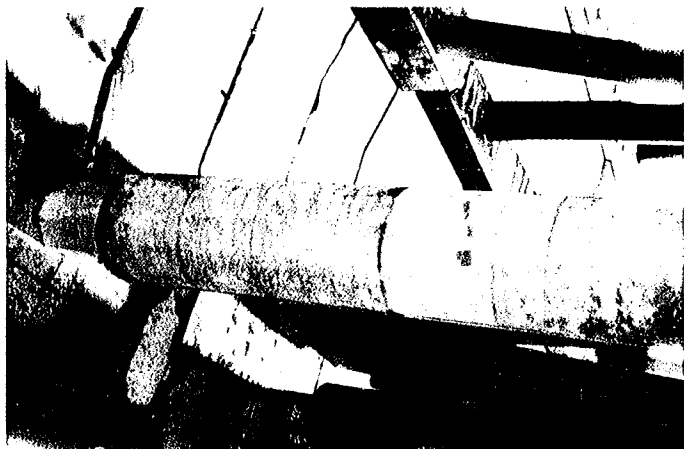
Fig. 9--Pile after repair — uncollated fibers

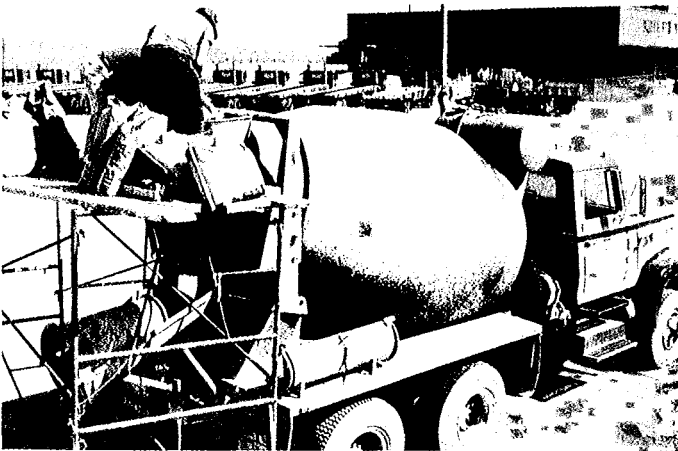
Fig. 12--Fibers added to truck mixes

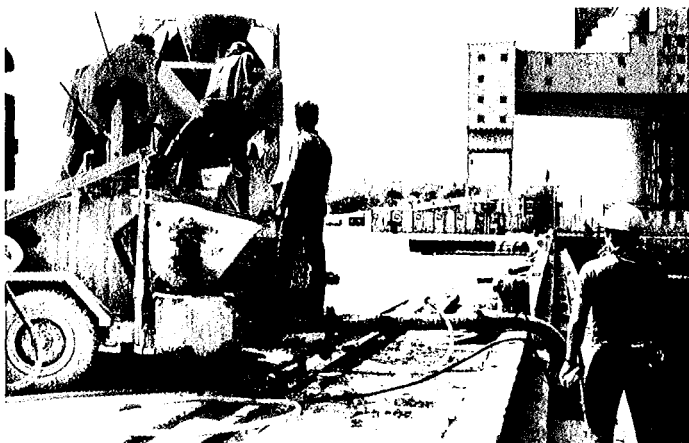
Fig. 13--Pumping SFRC

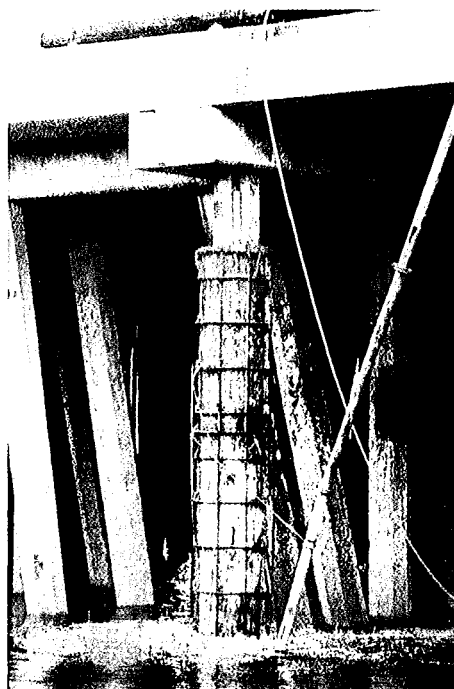
Fig. 14--SFRC overflowing form
