Introduction to Failure Analysis and Prevention

Roch J. Shipley, Professional Analysis and Consulting, Inc.
Brett A. Miller, IMR Test Labs
Ronald J. Parrington, Engineering Systems Inc.

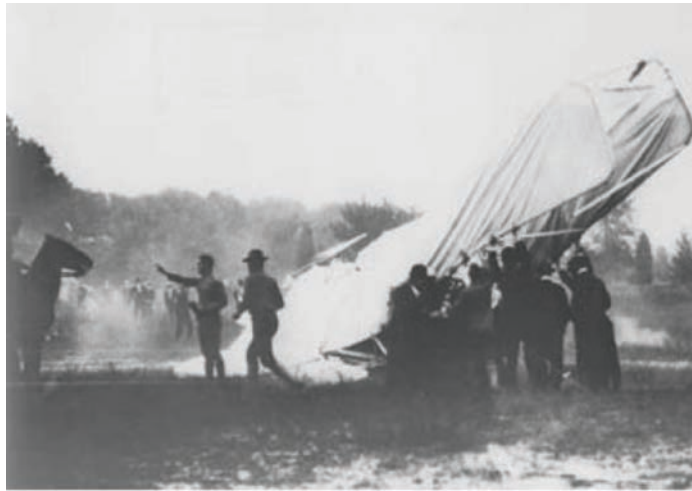
Fig. 1 Crash of the Wright Flyer, 1908. Courtesy of the National Air and Space Museum, Smithsonian Institution, Photo A-42555-A

The importance and value of failure analysis to safety, reliability, performance, and economy are well documented. For example, the importance of investigating failures was vividly illustrated in the pioneering efforts of the Wright Brothers in developing self-propelled flight. In fact, while Wilbur was traveling in France in 1908, Orville was conducting flight tests for the U.S. Army Signal Corps and was injured when his Wright Flyer crashed (Fig. 1). His passenger sustained fatal injuries (Ref 2). Upon receiving word of the mishap, Wilbur immediately ordered the delivery of the failed flyer to France so he could conduct a thorough investigation. This was decades before the formal discipline called “failure analysis” was introduced.

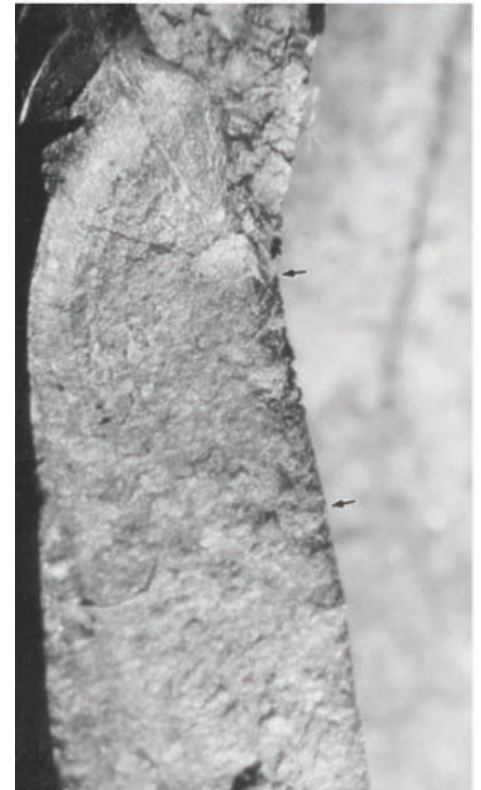
Fig. 22 Compressor blade fracture surface showing fatigue origins on low-pressure (i.e., right) side of blade, as indicated by the arrows. Original magnification: 13×

Careful fracture analysis revealed fatigue cracks initiated on the low-pressure side of the blades, which are in compression during normal compressor operation. However, when the inlet flow is blocked, particularly when the blockage is only partial, the blades sustain alternating tensile forces, one load cycle per revolution, on the low-pressure side of the blades, resulting in the observed blade
