3 DETAILED OBSERVATIONS ON THE TANKS THAT WERE INSPECTED

3.1 TANK A

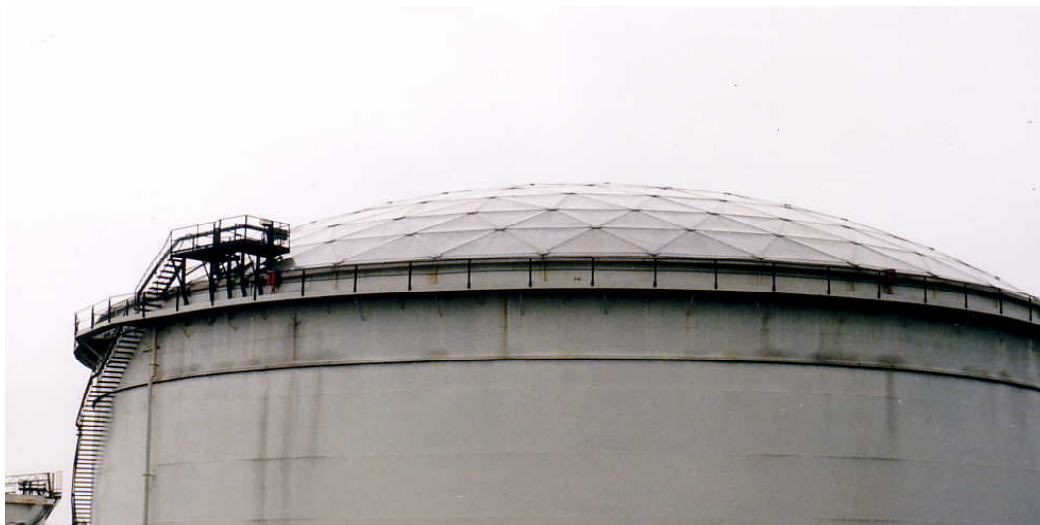
One geodesic roof tank was viewed at some distance (see Photograph 2), the roof of which was said to be of bolted construction, but the skin thickness of the aluminium panels is not known at the present. The steel cone roof tanks have steel at least 5 mm thick so they are able to carry the high current safely. There remains the possibility that an incendiary hot-spot could form on the back surface of an arc attachment point. This is discussed in EI-TN1-03 *Review of burn-through and hot-spot effects on metallic tank skins from lightning strikes*.

Photograph 3 Geodesic tank roof at an overseas refinery
