4.12 Masonry Barrel

4.13 Timber Barrels

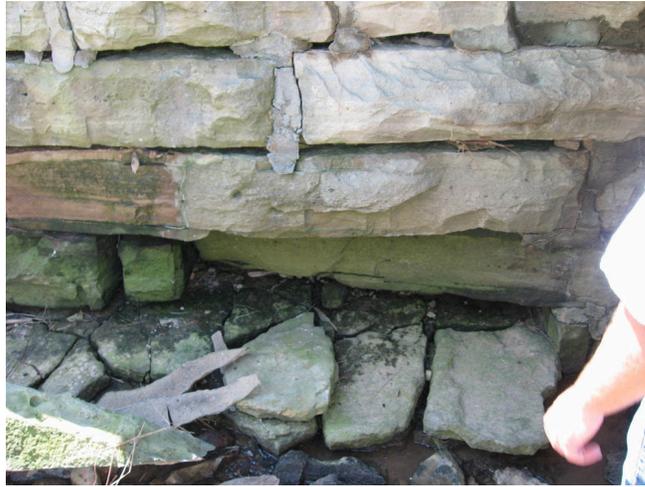
The individual stones, bricks, or blocks should be checked for displaced, cracked, broken, crushed, or missing units. For some types of masonry, surface deterioration or weathering can also be a problem and can cause spalling.

Figure 4.12.2-1—Missing Units in Masonry Barrel Wall with Cracked and Missing Mortar

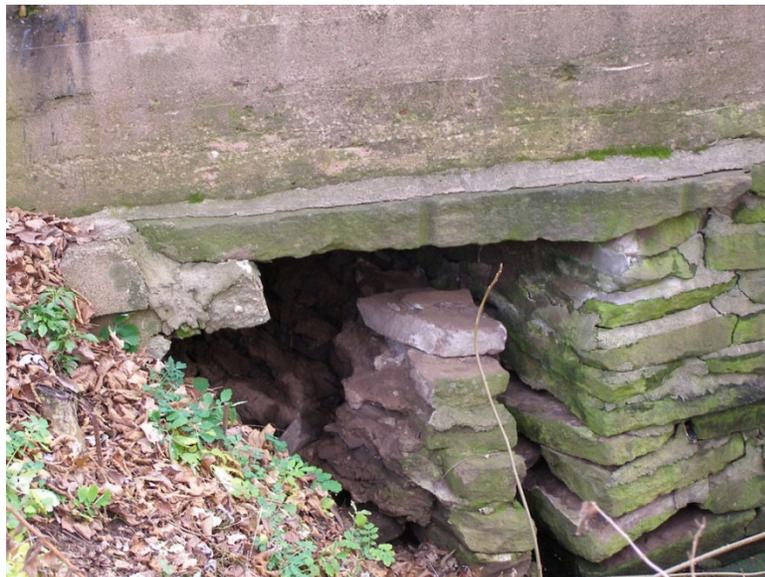
Movement of individual or grouped masonry units may occur due to freeze–thaw action, vegetation growth, mortar deterioration, or stress. The Inspector should identify loose or dislodged units.

Figure 4.12.2-2—Structure Condition is Severe and Unstable Due to Movement of Foundation Wall

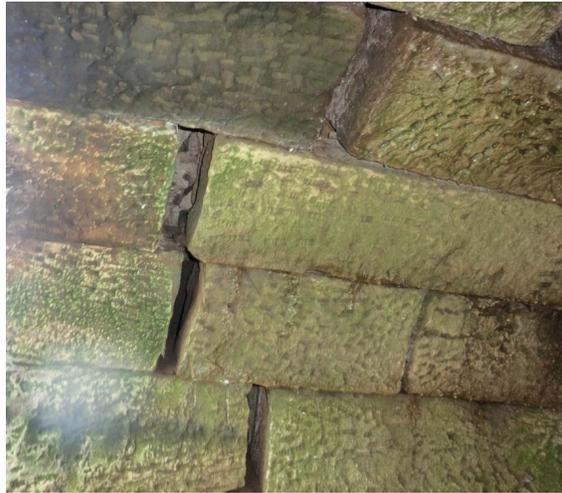
In most masonry arch culverts, mortar is used to bond the masonry units together. The condition of the mortar should be checked to ensure that it is still holding strongly. It is particularly important to note cracked, deteriorated, or missing mortar especially if other deterioration is present such as loose or missing masonry units. The presence of dirt or vegetation between masonry units should be noted as these can be indicators of loss of backfill or erosion behind the structure. Water infiltration can also contribute to mortar distress in cold climates as freeze–thaw cycles break the mortar apart.

Figure 4.12.2-3—Missing Mortar between Masonry Units

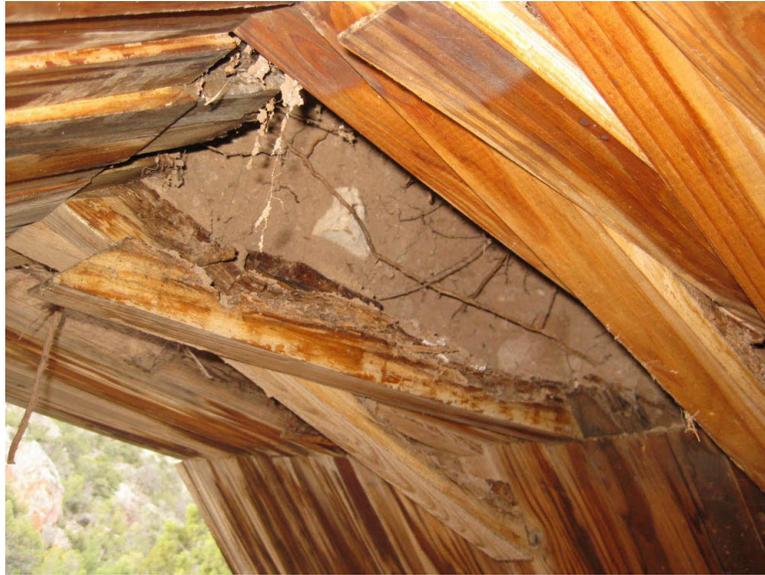
Missing members may be due to structural failure of the member or its connection, or impact from stream or ice flows. Other activities such as installation of utilities or structure modifications may remove a member in whole or part (i.e., notched or cored beam for utility conduit).

Figure 4.13.2-2—Connection Failure Causing Partial Collapse of Member and Missing Members Allowing Loss of Backfill

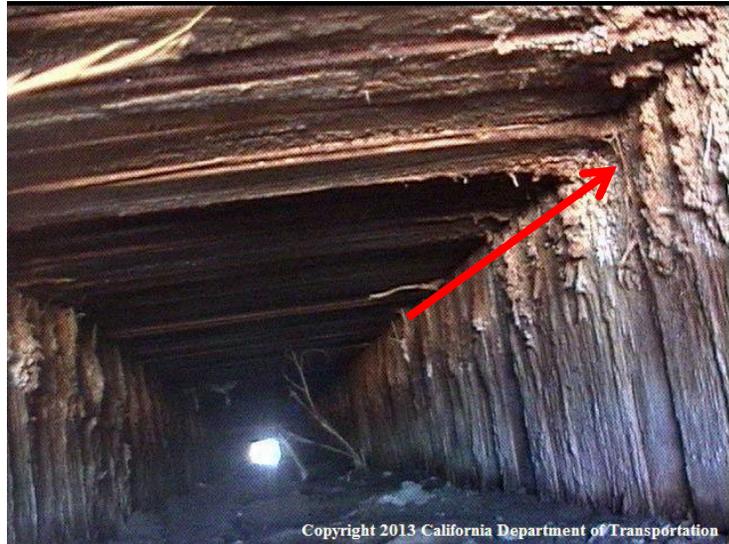
club-shaped fungi. Fruiting bodies provide positive indication of advanced fungal attack, but do not indicate the amount or extent of decay. Some species of fungi produce fruiting bodies after small amounts of internal decay have occurred, while others develop only after decay is extensive. Fruiting bodies almost certainly indicate serious decay problems when they are present.

Figure 4.13.2-4—Fruiting Bodies on Timber Culvert Members
(Photo courtesy of California Department of Transportation)

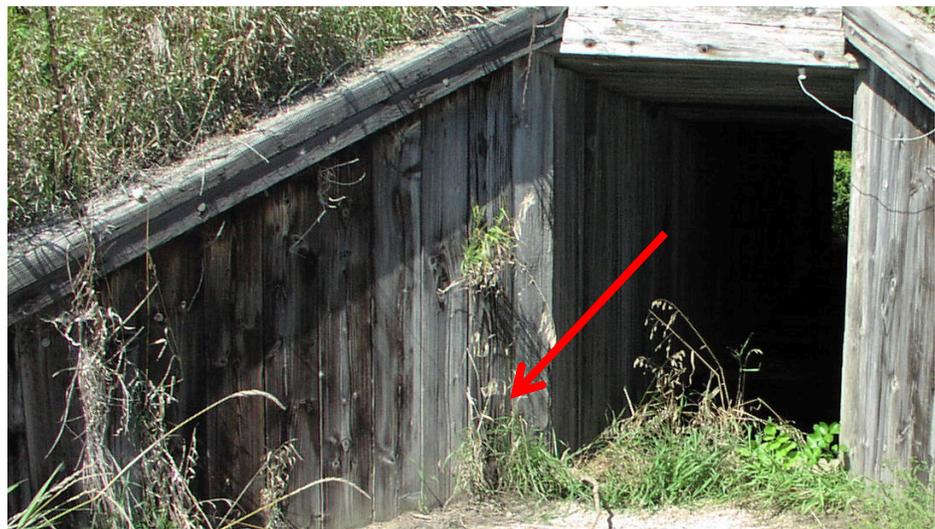
Sunken faces or localized surface depressions can indicate underlying decay. Sunken faces occur when a thin layer of intact or partially intact wood forms a depression over voids or pockets near the surface of the member.

Staining and discoloration are indicators of potential decay. Members with staining have been subjected to water and potentially high moisture contents and stained areas may mean conditions are suitable for decay. Rust stains on a member face may indicate wetting-induced deterioration of the connection hardware. These areas should be noted for future monitoring.

Figure 4.13.2-5—Staining and Sunken Faces on Timber Culvert Members
(Photo courtesy of Colorado Department of Transportation)

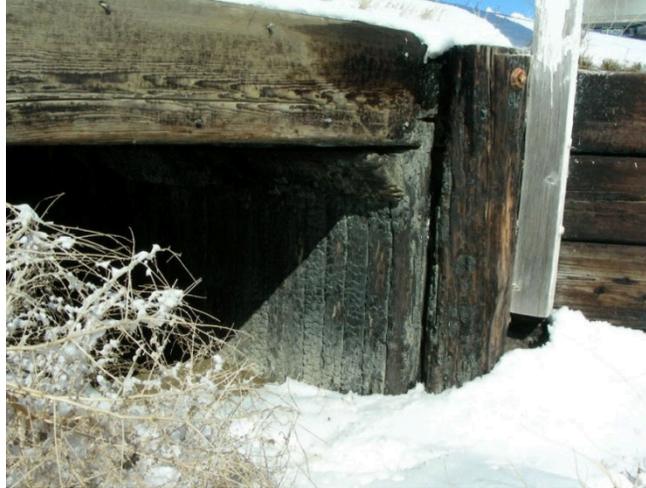
The extent of any charring and fire damage should be noted by the Inspector. Large wood members often retain structural strength after fire damage and an in-depth inspection by an Engineer is required to determine the residual capacity or to design for repair or replacement.

Figure 4.13.2-6—Fire Charring on Timber Culvert Members

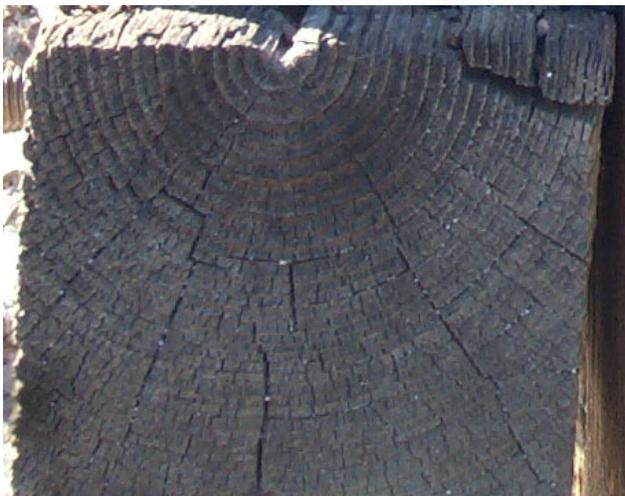
Checks are shrinkage cracks that occur along the radius of solid sawn timber, usually perpendicular through the growth rings. Checks can be seen along the face of members and are typically not a structural problem as they are accounted for in the engineering design values for strength. Severe checking at connections can weaken the ability of fasteners to carry load and should be flagged during inspections.

Figure 4.13.2-7—Checks in Timber Culvert Member

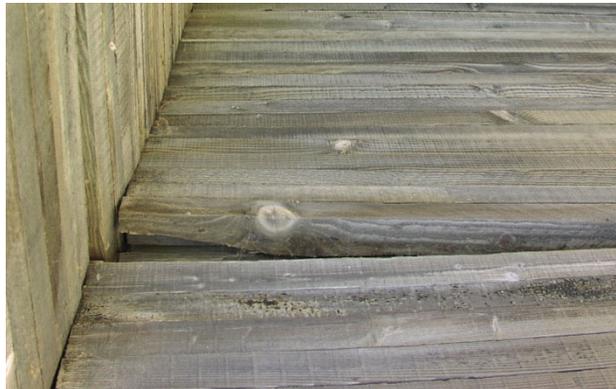
Distortion of members can include warping, sagging, or local crushing. Warping is characterized by deviation from flatness as a result of stresses and uneven shrinkage. Sagging is vertical deformation that can be caused by overloading or by creep (permanent deformation due to constant loading over time). Crushing typically occurs at connections where a member supports a vertical load bearing perpendicular to the direction of the wood grain.

Figure 4.13.2-8—Warping of Timber Culvert Member
